## **Property Condition Assessment Report**

# Public Utilities Commission Building 1155 Main Street Any City, Any County, Any State NDDS Project No.: 00-0000 Date Issued December 3, 2019

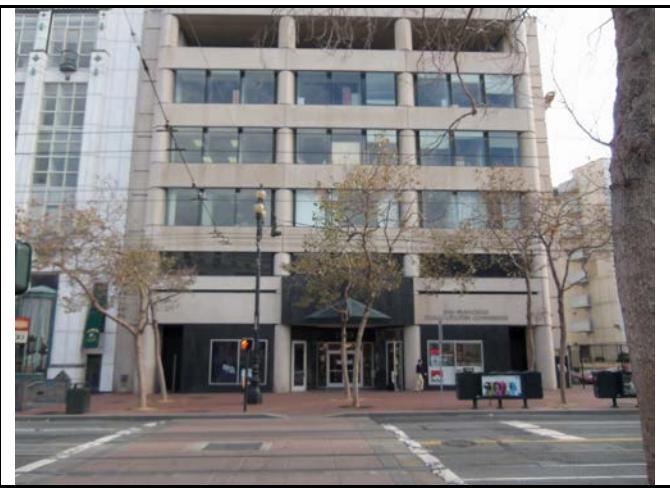
Photo 1. North side of the building, street view

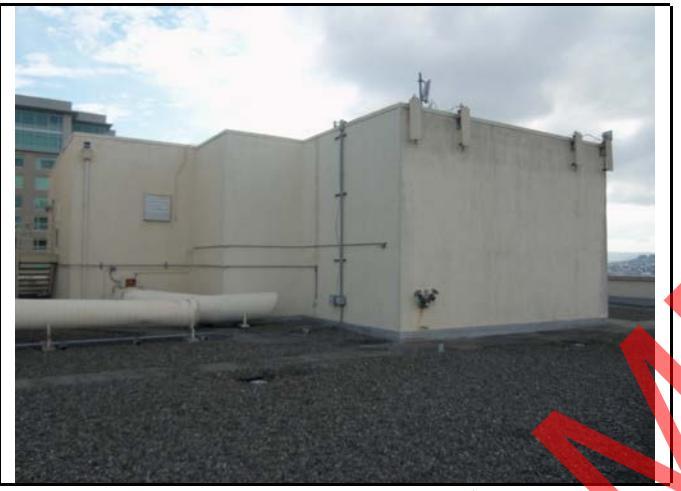
Photo 3. Roof, Penthouse structure

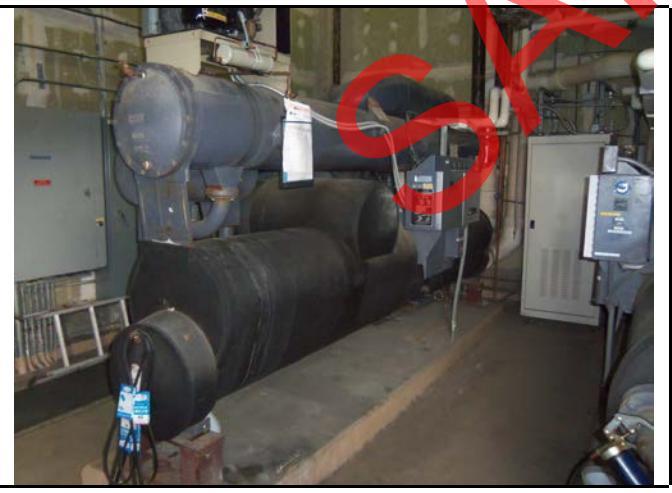
Photo 5. Typical Centrifugal Chiller

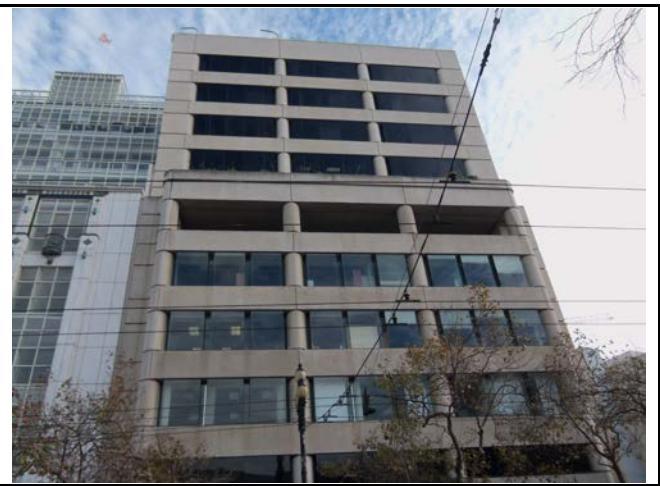
Photo 2. North side of the building, upper stories

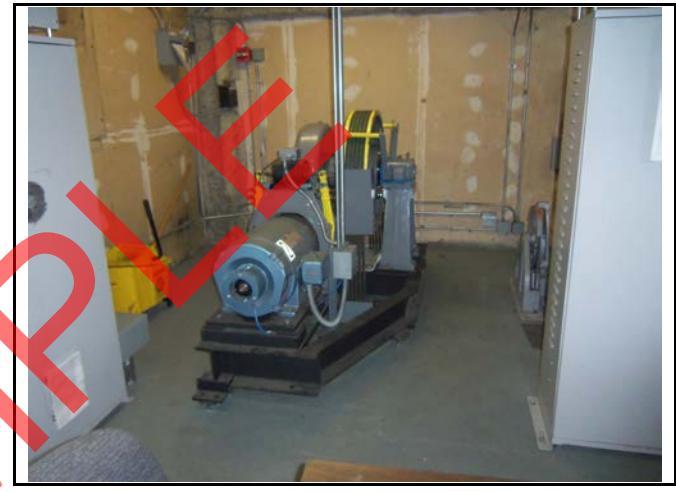
Photo 4. Typical elevator hoist

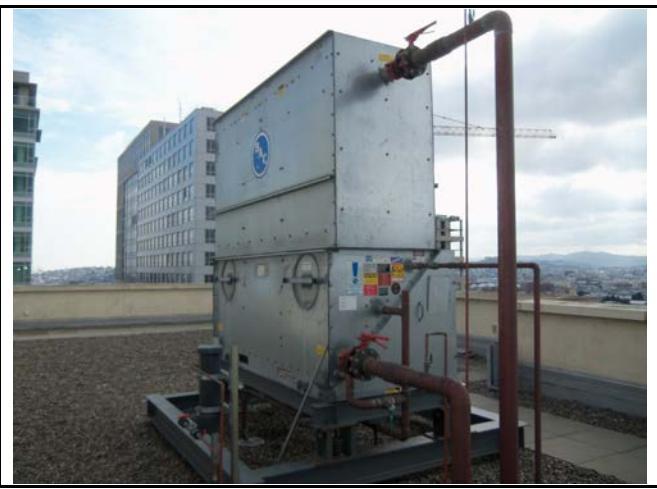
Photo 6. Small cooling tower

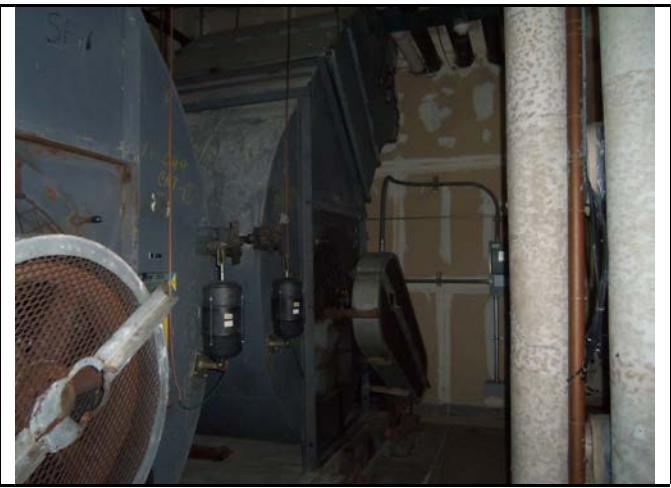
Photo 7. Supply air circulation fans

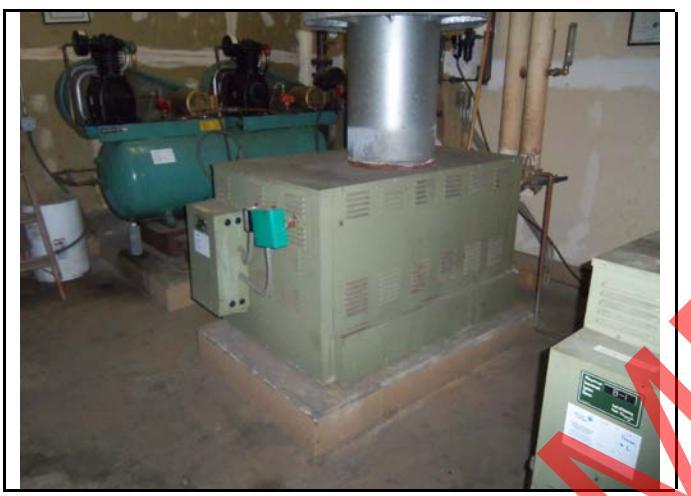
Photo 9. Gas-fired hot water boiler & compressor

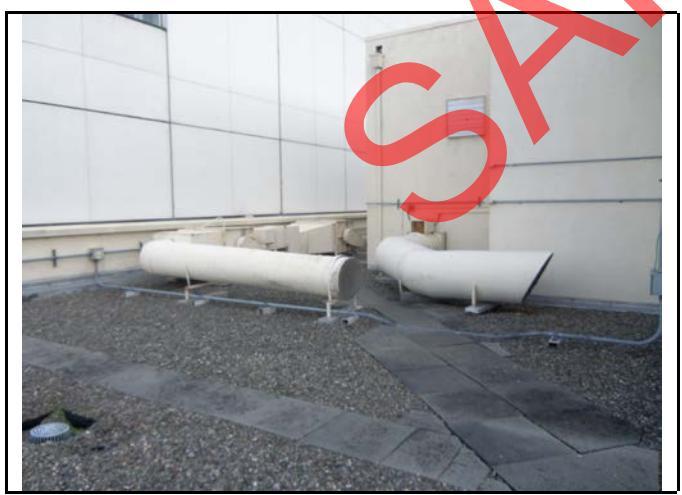
Photo 11. Roof

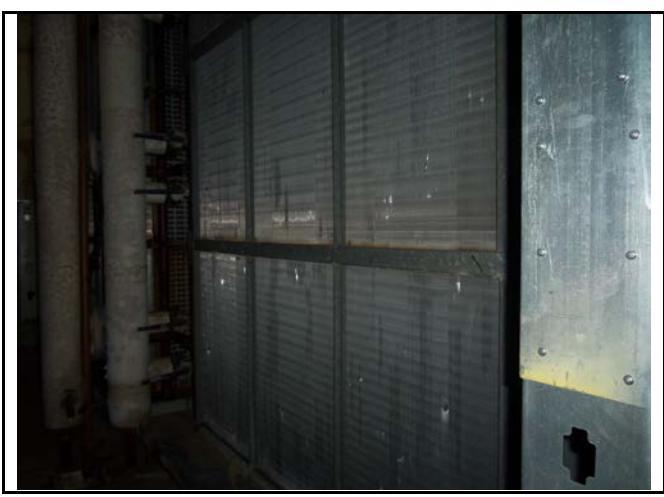
Photo 8. Cooling coils

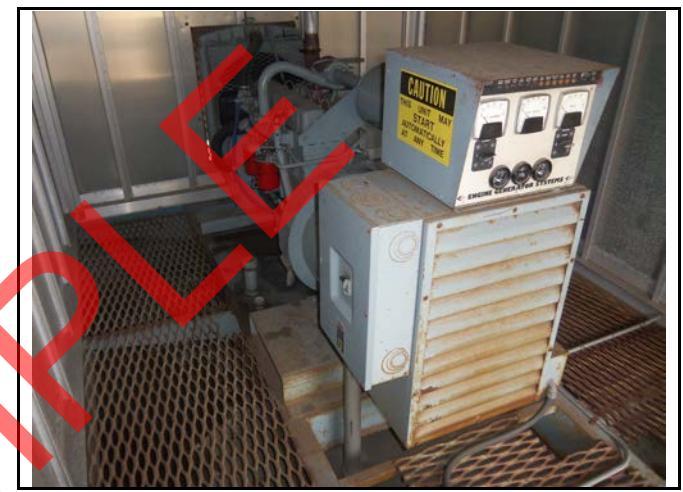
Photo 10. Emergency generator w/diesel belly tank (AST)

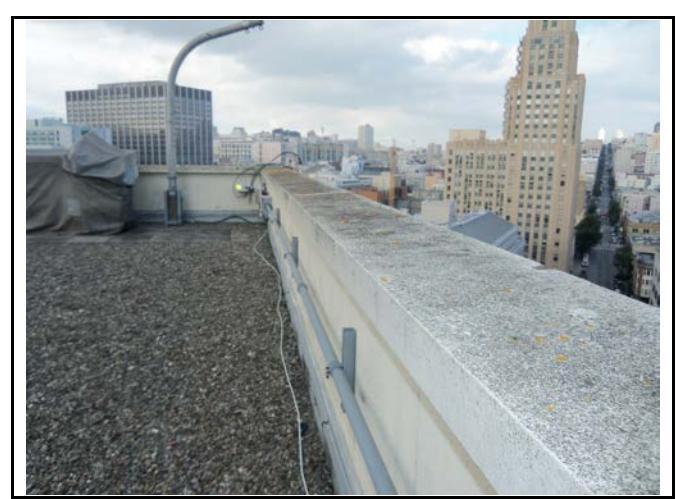
Photo 12. Parapet & wall caps

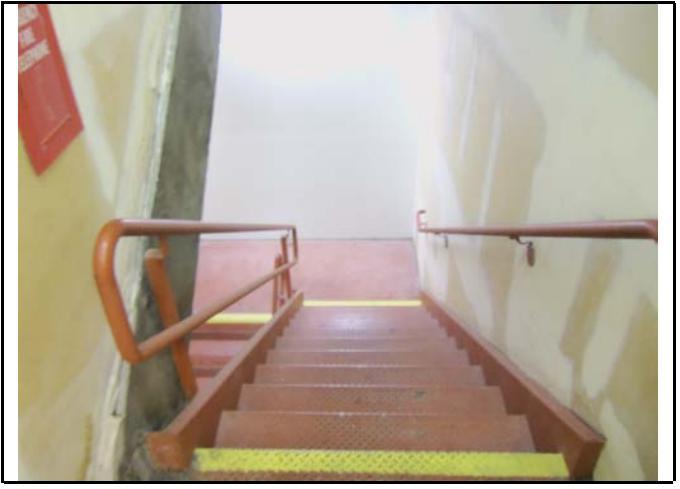
Photo 13. Typical egress stairway

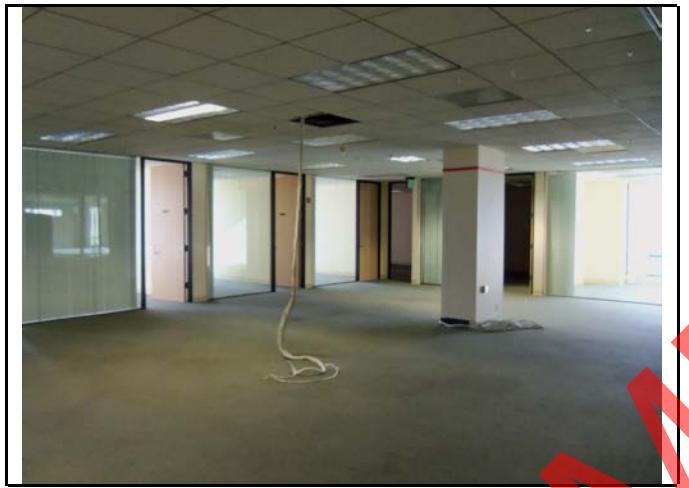
Photo 15. Typical unoccupied tenant space

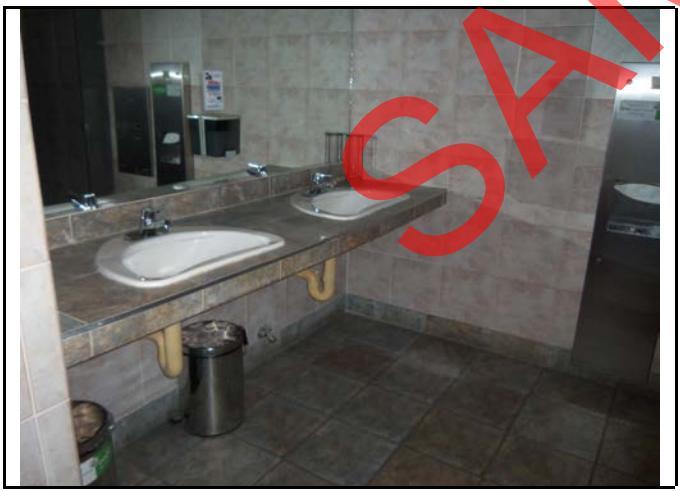
Photo 17. Typical restroom w/sinks & fixtures

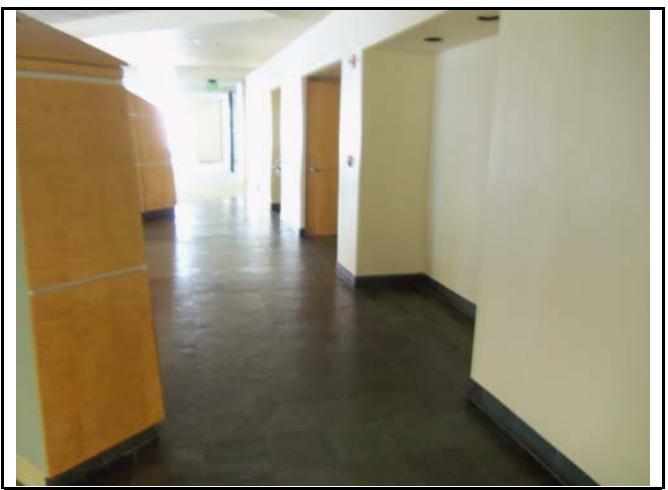
Photo 14. Typical tenant corridor

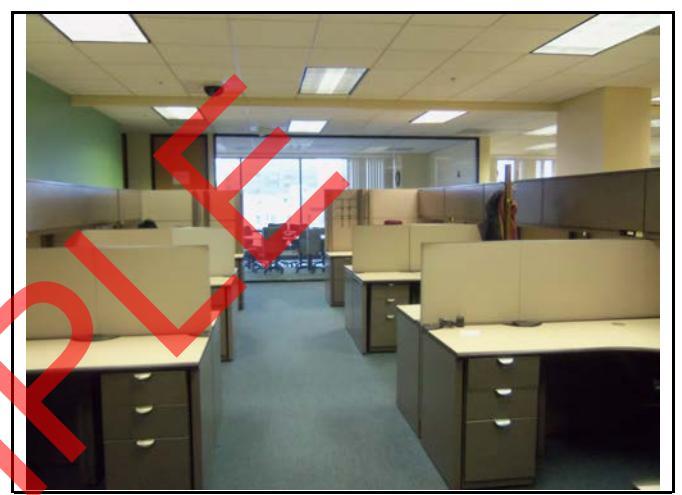
Photo 16. Typical occupied tenant space

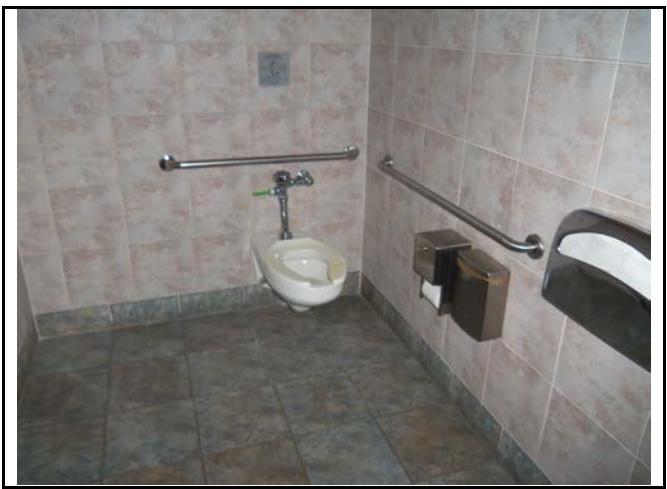
Photo 18. Typical ADA stall w/toilet & fixtures

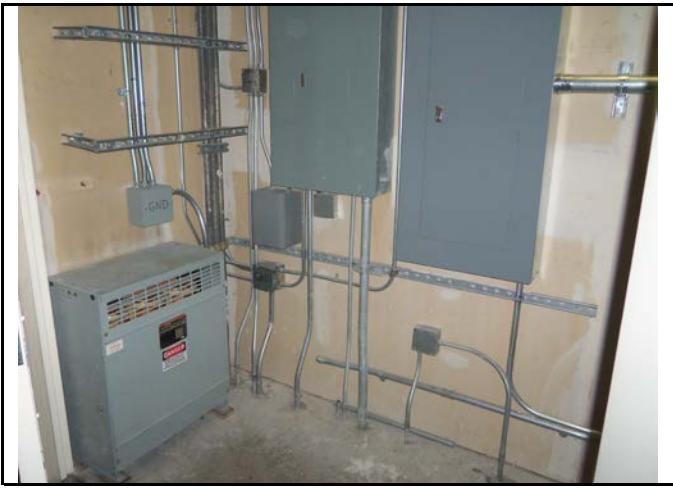
Photo 19. Typical electrical room

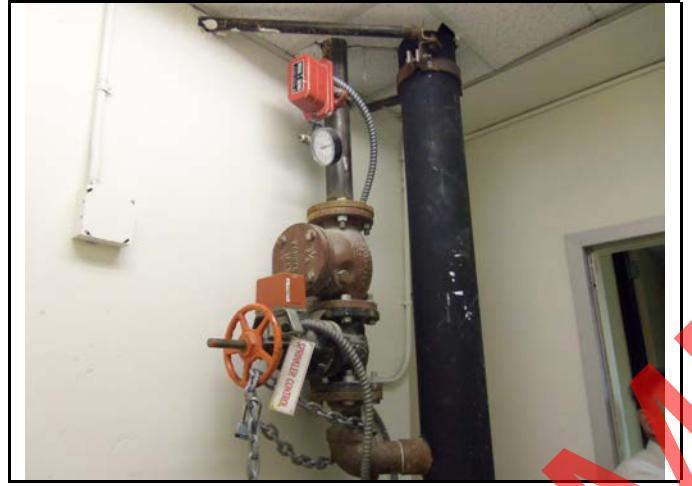
Photo 21. Typical fire riser

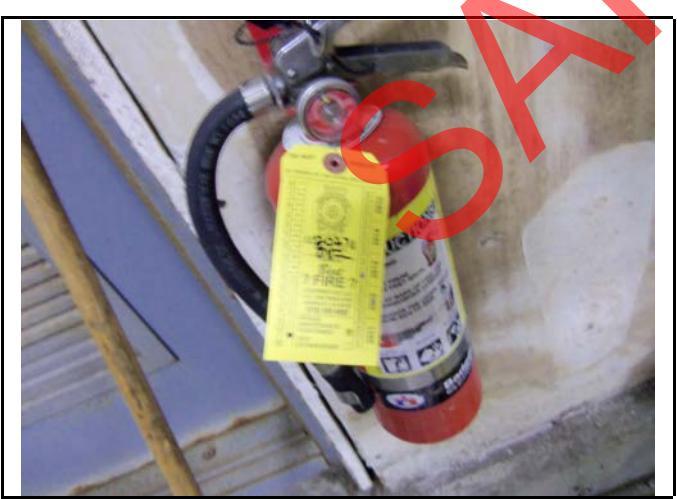
Photo 23. Typical fire extinguisher & inspection tag

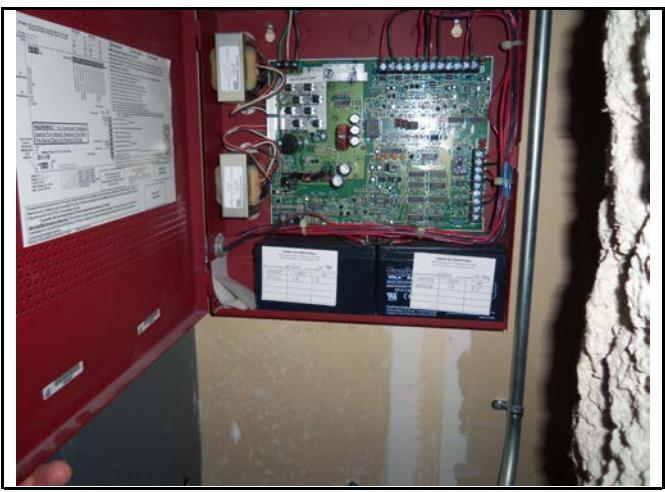
Photo 20. Typical fire panel

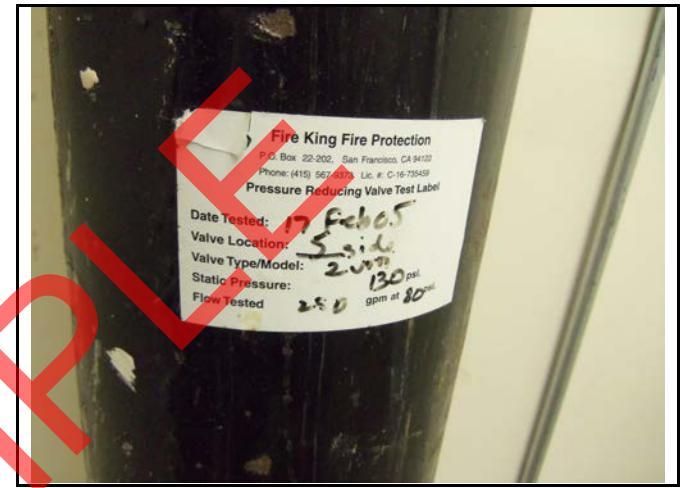
Photo 22. Typical fire riser inspection label

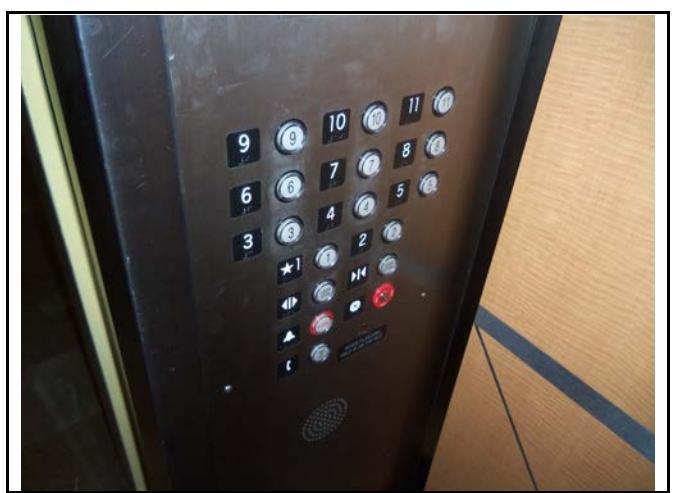
Photo 24. Typical elevator cab control panel

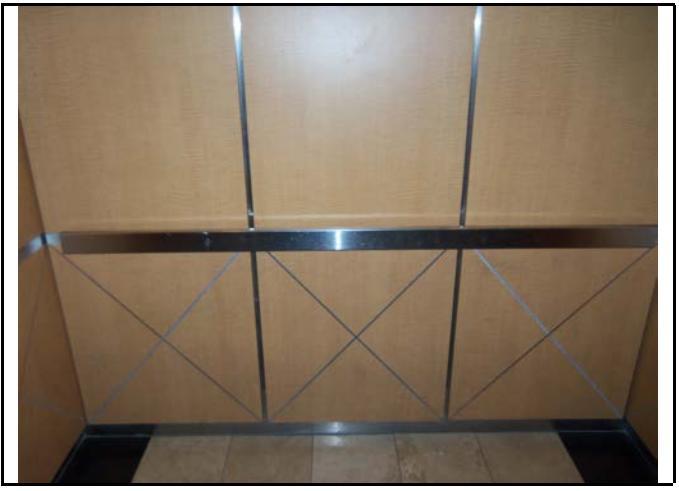
Photo 25. Typical elevator cab interior

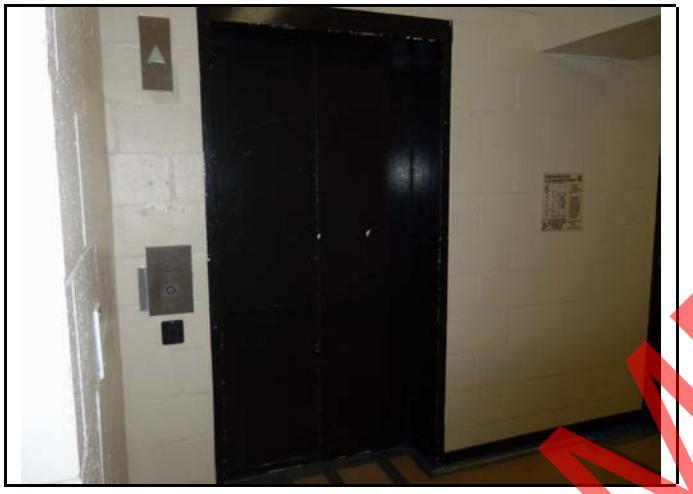
Photo 27. Elevator #1, basement/garage access

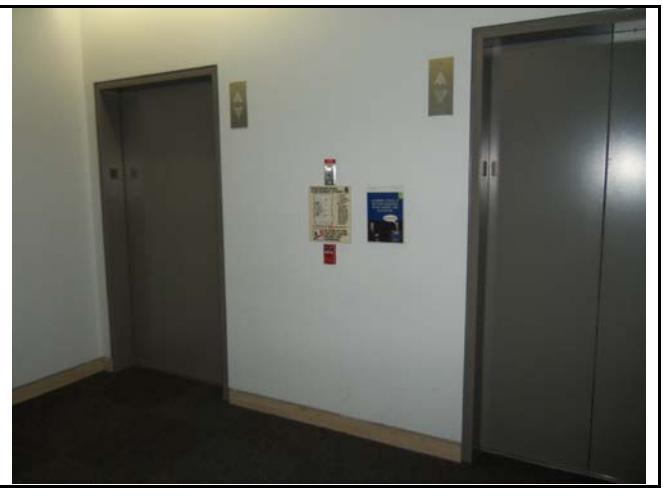
Photo 26. Typical elevator lobby

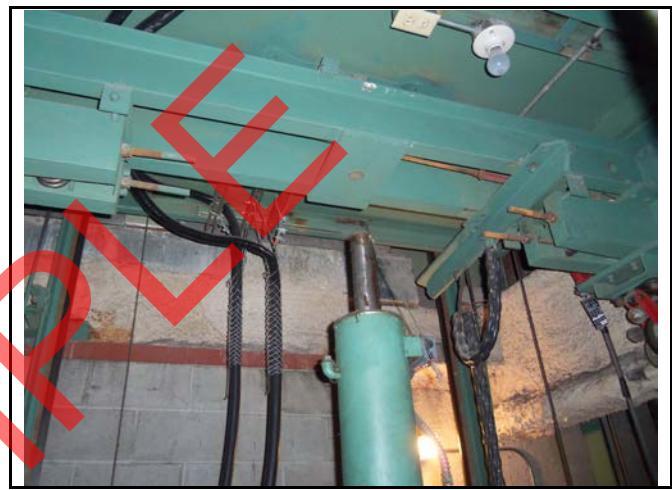
Photo 28. Elevator pit room

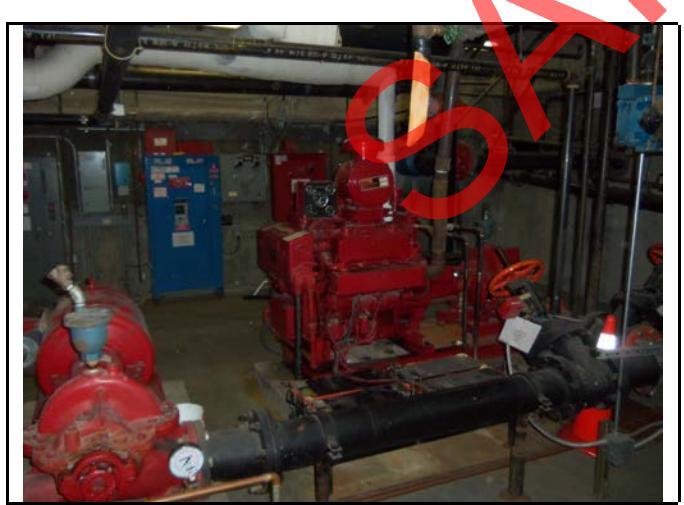
Photo 29. Fire riser pump room

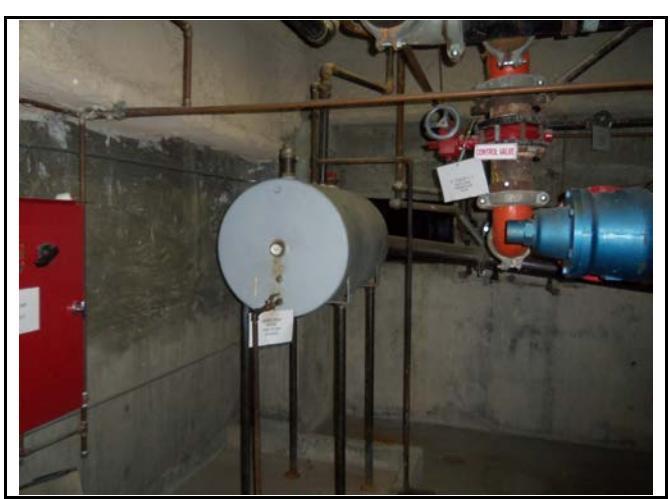
**Photo 30.** Diesel AST for the fire riser emergency generator

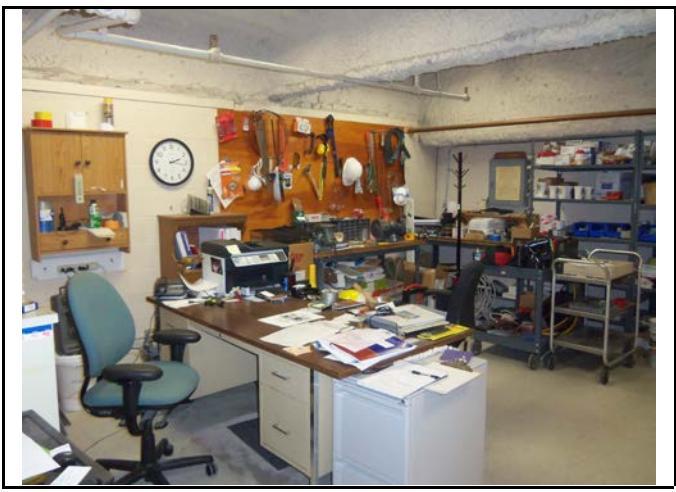
Photo 31. Site Manager/maintenance room

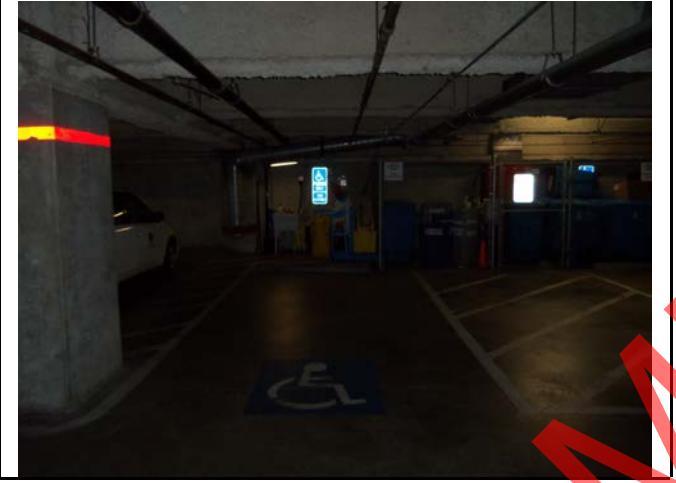
Photo 33. Typical ADA space, basement parking garage

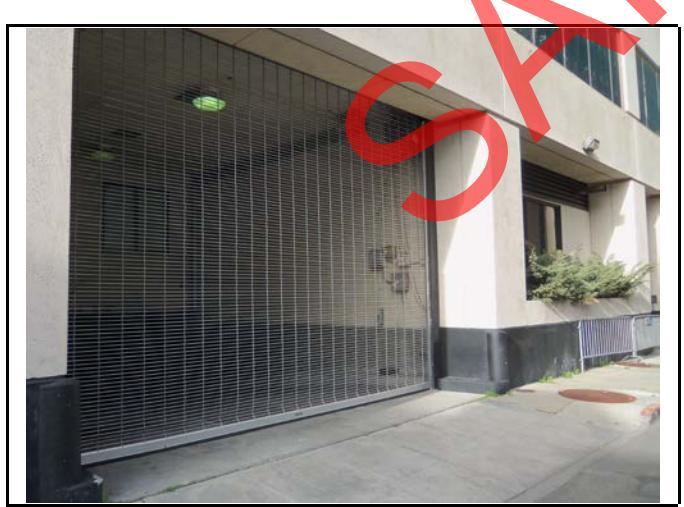
Photo 35. Entrance to the underground garage

Recommendations: Consideration should be taken concerning correcting/ simplifying vehicular overhead door operation and entry/exit from the underground garage in the event of emergency including power failure. The cost for this work is minimal; it is not included in the expenditure tables.

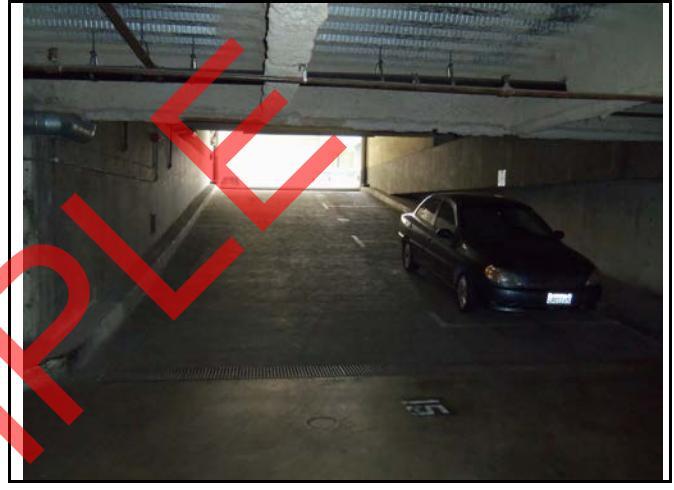
Photo 34. Ramp for the underground garage

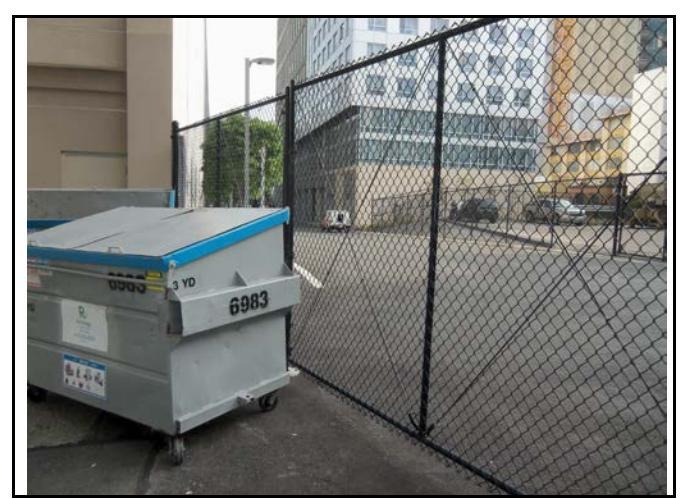
Photo 36. Solid waste container
